**BLM Cedar City Field Office
Site Inspection Report**

October 23, 2009

File: UTU-80852; Blawn Mountain Kaolin Mine Project
Sandy Nell / Lone Star Mining

Inspector: Ed Ginouves, CCFO Mining Engineer

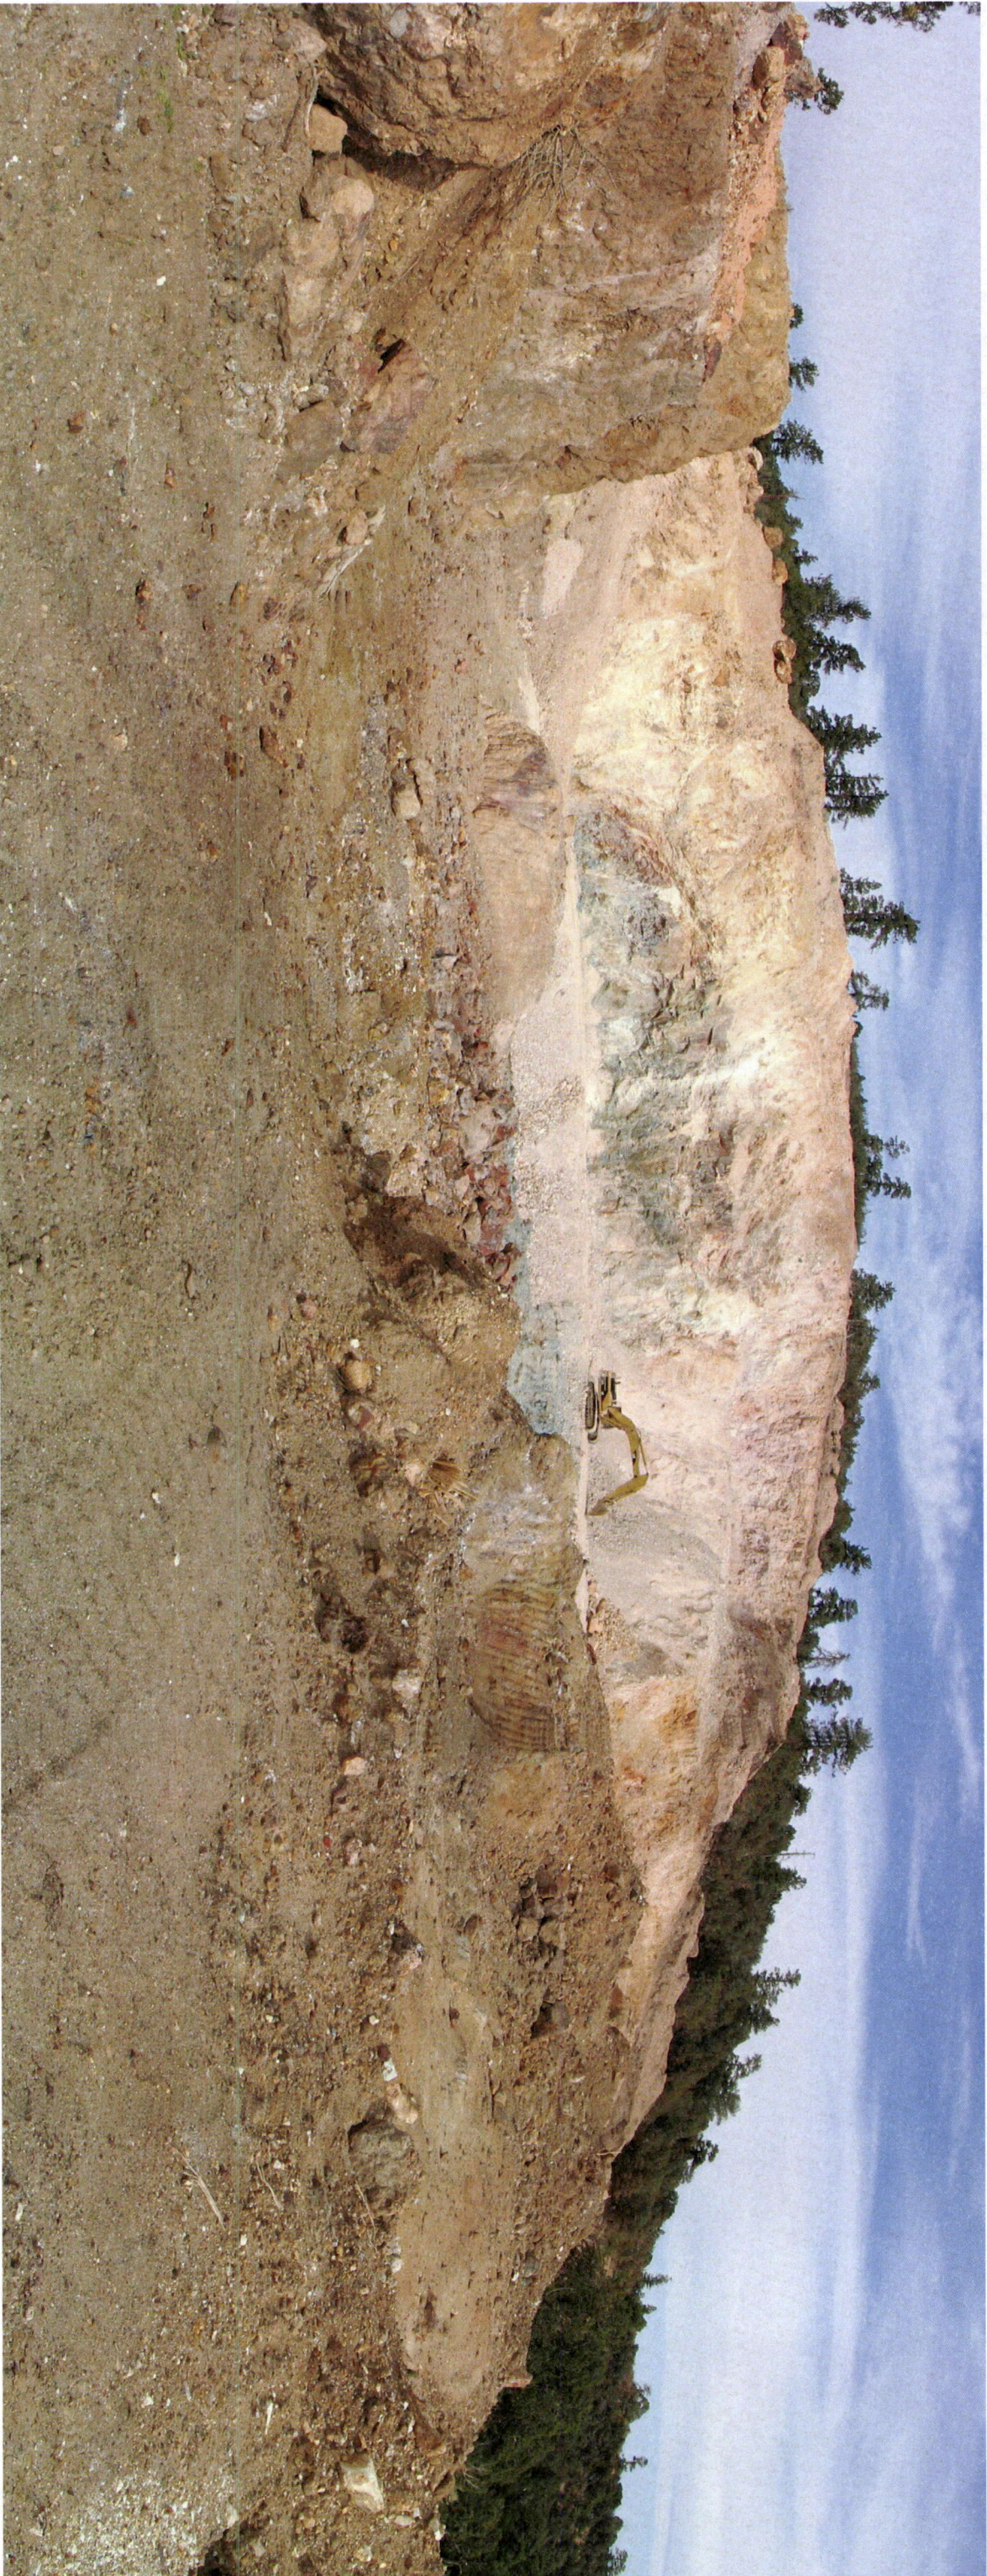
UTU-80852: Blawn Mtn. Kaolin
October 22, 2009

Panoramic view of mine site looking north from the southern edge of the disturbance. The mound in the center is an area of dolomite. The pinkish band above the trackhoe is a zone of alunitic clay that is unminable due to excessive alkali metal content. The same zone lies ten feet behind the dark grey face to the left of the trackhoe. This face would be benched to create a reclaimable slope. The eastern edge of the site, in the right hand side of this view, would be reclaimed.

The exploratory drilling suggests that the remaining clay resource is in a northeast-southwest trending zone through the site. Mr. Nell said his plan was to reclaim ~ 2 acres within the east, southeast and western perimeter of the current site to free up an additional acre of needed expansion both on the north-northeast and on the southwest of the existing site.

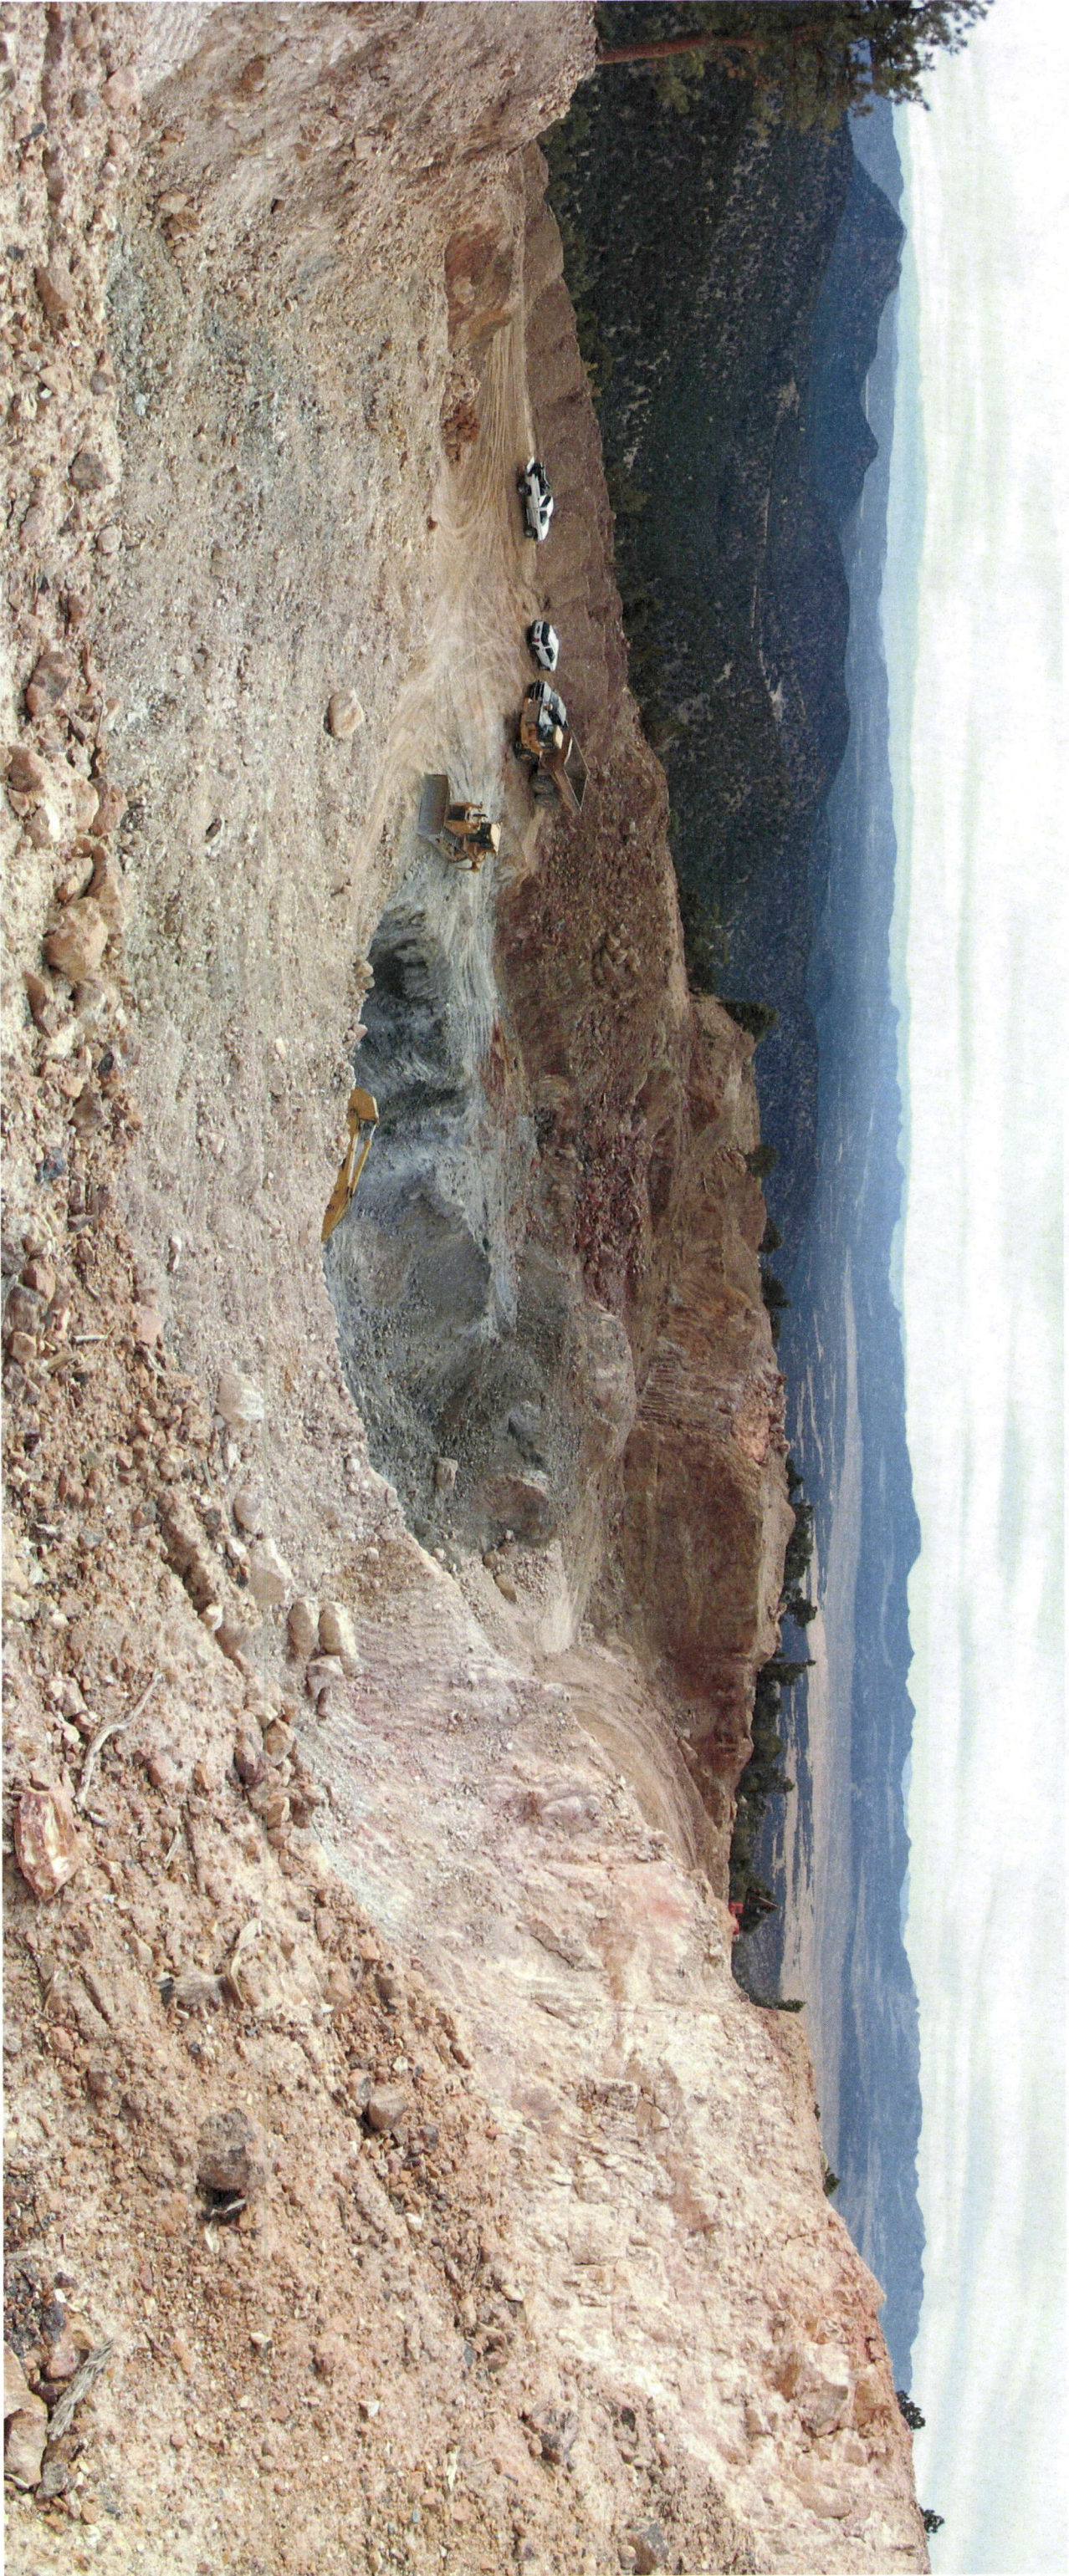
UTU-80852: Blawn Mtn. Kaolin
October 22, 2009

Panoramic view of mine site looking south from the northern edge of the disturbance. Note dark grey high pyrite/ iron oxide area in pit bottom.

There had been a recent blast in the pit bottom which is a dark-grey, pyritized zone. Mr. Nell said that holes drilled through this showed it is limited in depth and deeper down the cutting were lighter colored. The alumina grade of the material is still in the mid 30%.

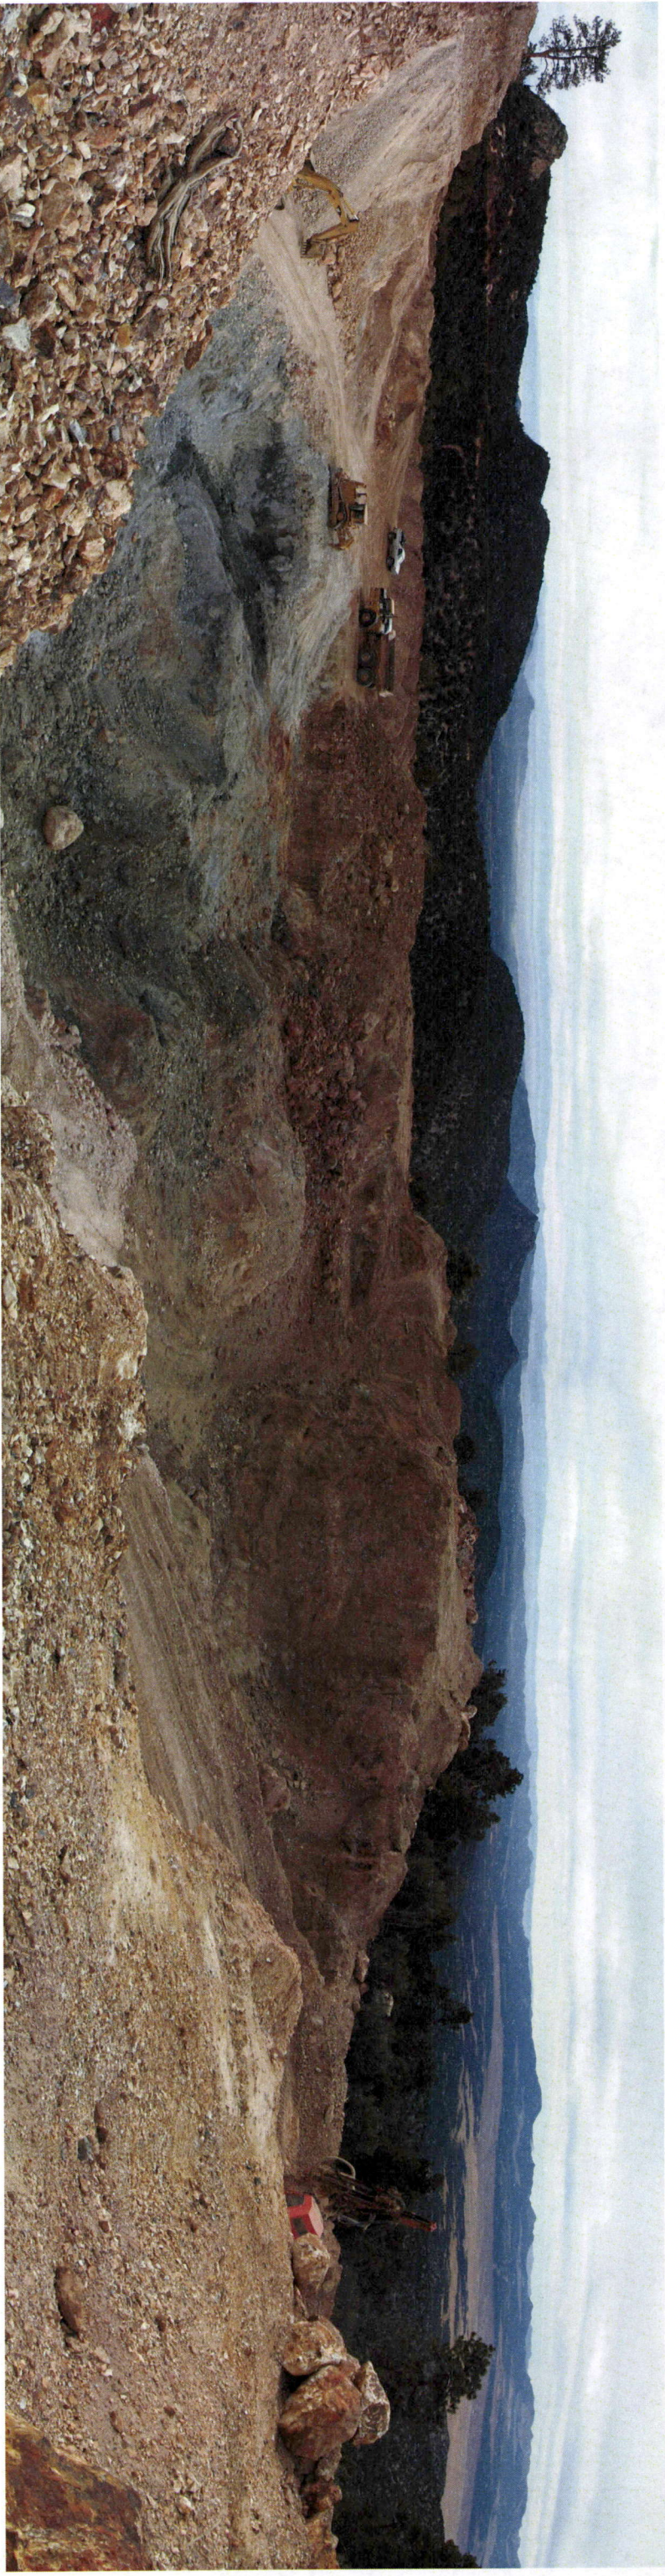
UTU-80852: Blawn Mtn. Kaolin
October 22, 2009

Panoramic view of mine site looking easterly from the southwest edge of the disturbance.

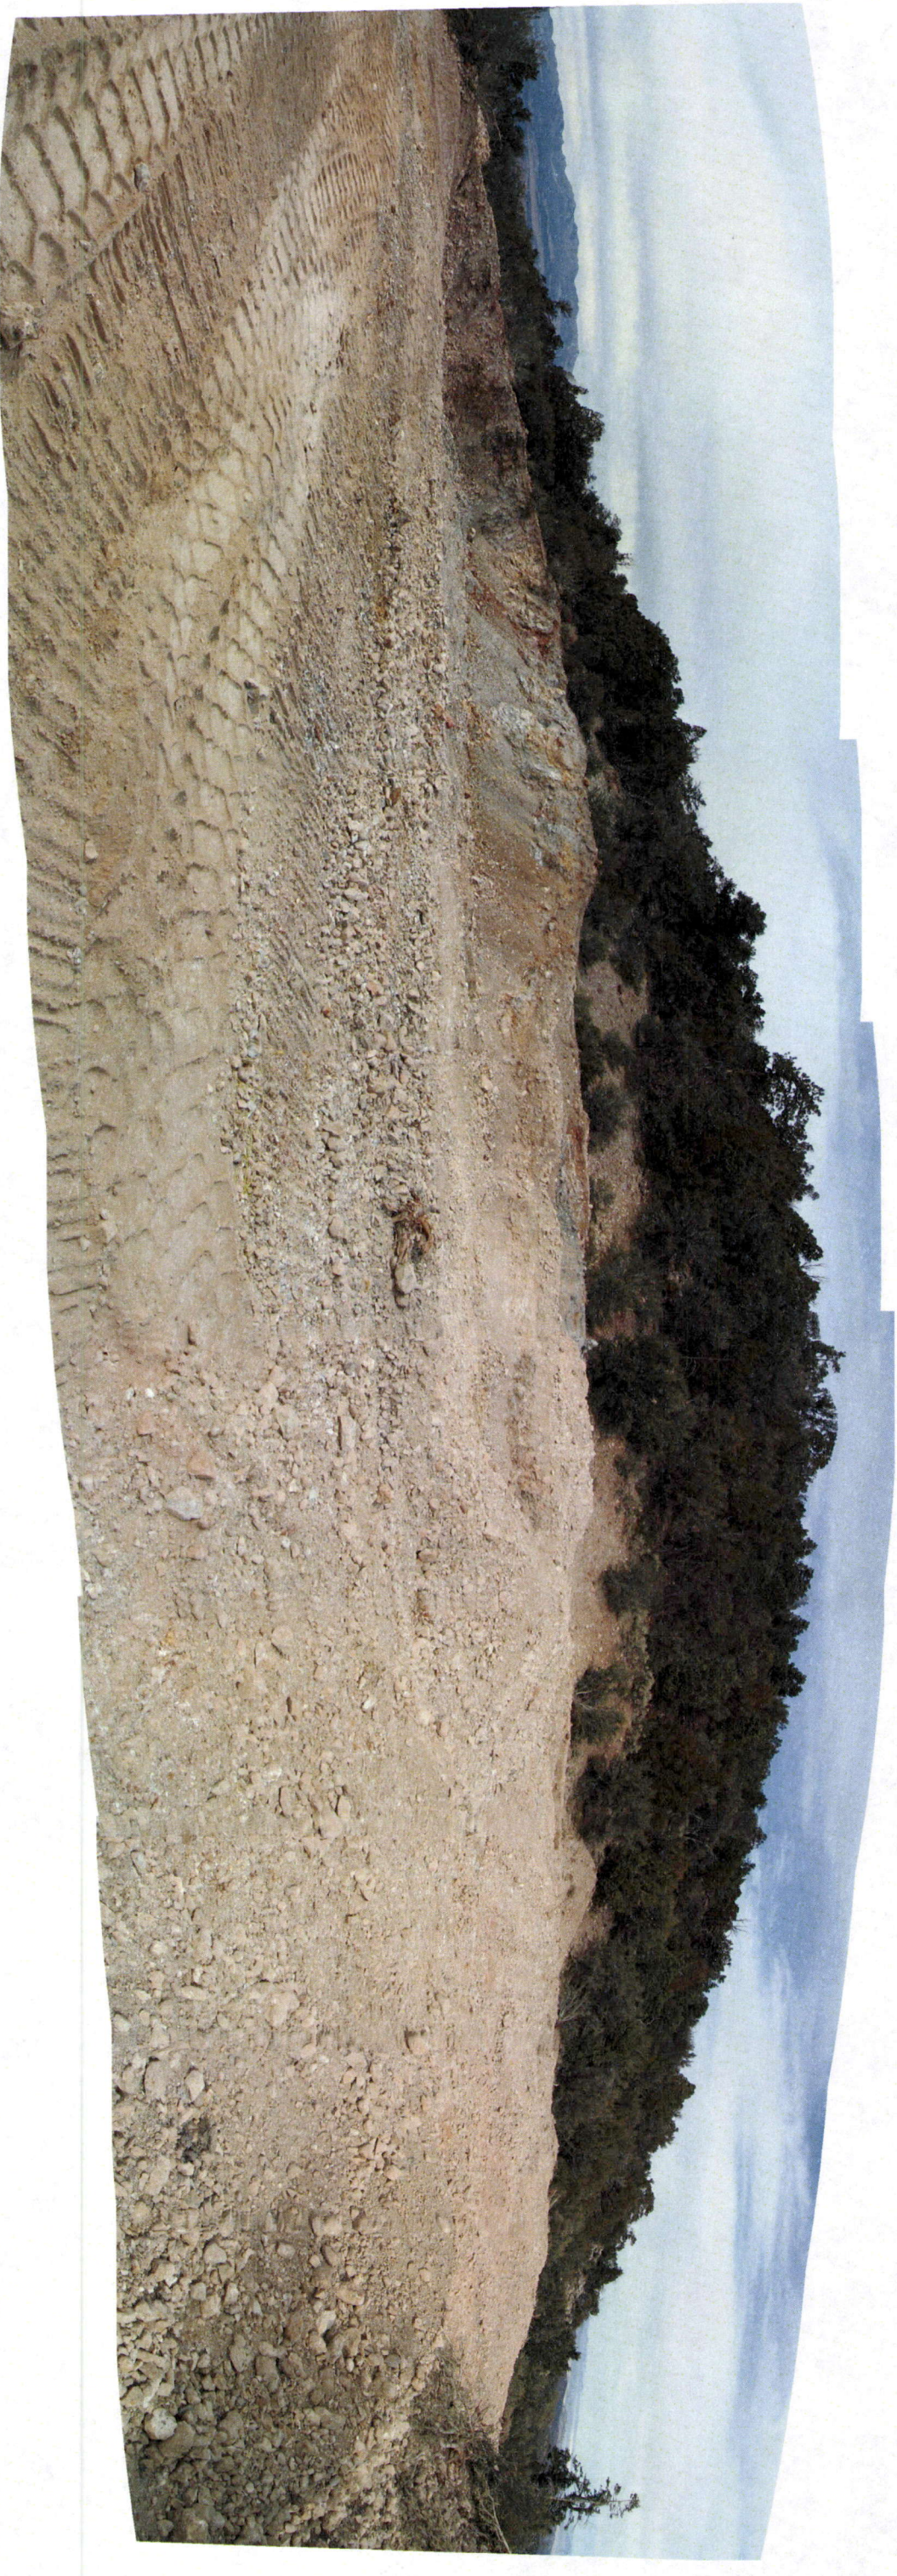
UTU-80852: Blawn Mtn. Kaolin
October 22, 2009

View of a ~1/2 acre unauthorized bulk sampling effort 1/4 mile to the northwest of the mine site on the summit of Blawn Mtn.

directed Mr. Nell that he would need to reclaim this unauthorized excavation immediately as it was in non-compliance. The gross disturbed footprint of the minesite (not counting the unpermitted bulk sampling area) is 5.5 acres and will require some reduction in size to remain permitted as a small mine operation under DOGM rules. I also reminded Mr. Nell that he should not take liberties with drilling even shallow, small dia. exploration holes unpermitted outside of the approved mine site footprint.

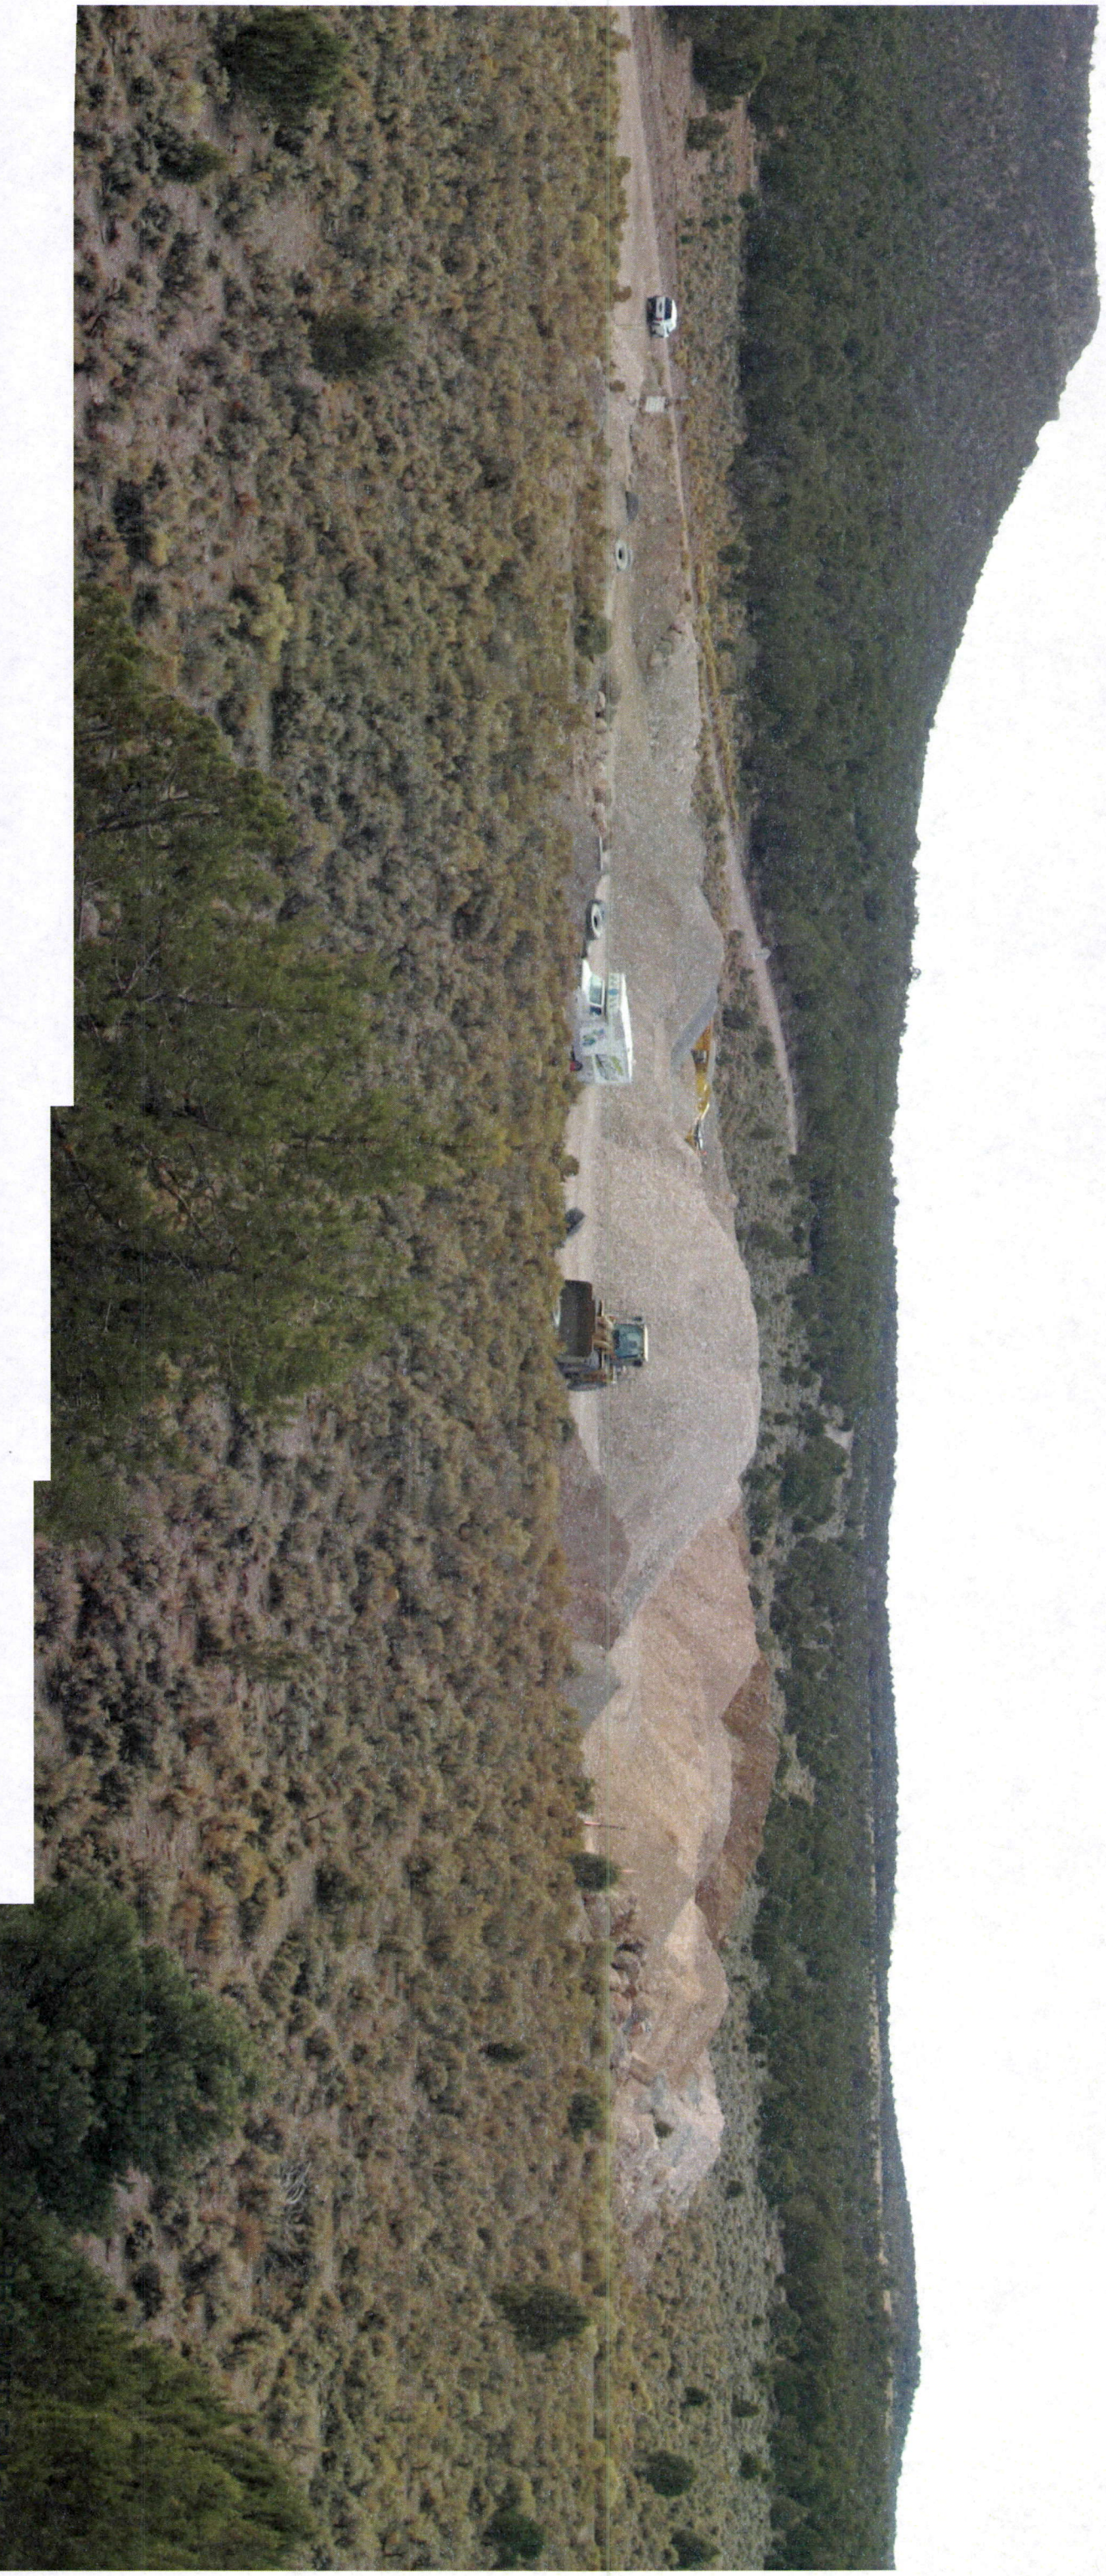
The Jockey Road/Seeps Road stockpiling area was full to capacity. The operator had pushed rock material into a berm around the perimeter, burying the prior berm of salvaged topsoil (a violation). The gross disturbed footprint had been marginally increased to 3.0 acres.

UTU-80852: Blawn Mtn. Kaolin
October 22, 2009
Panoramic view of the Jockey Road crushing/stockpiling area, located at the junction of the Seeps and Jockey Roads. View looking westerly from adjacent hillside.

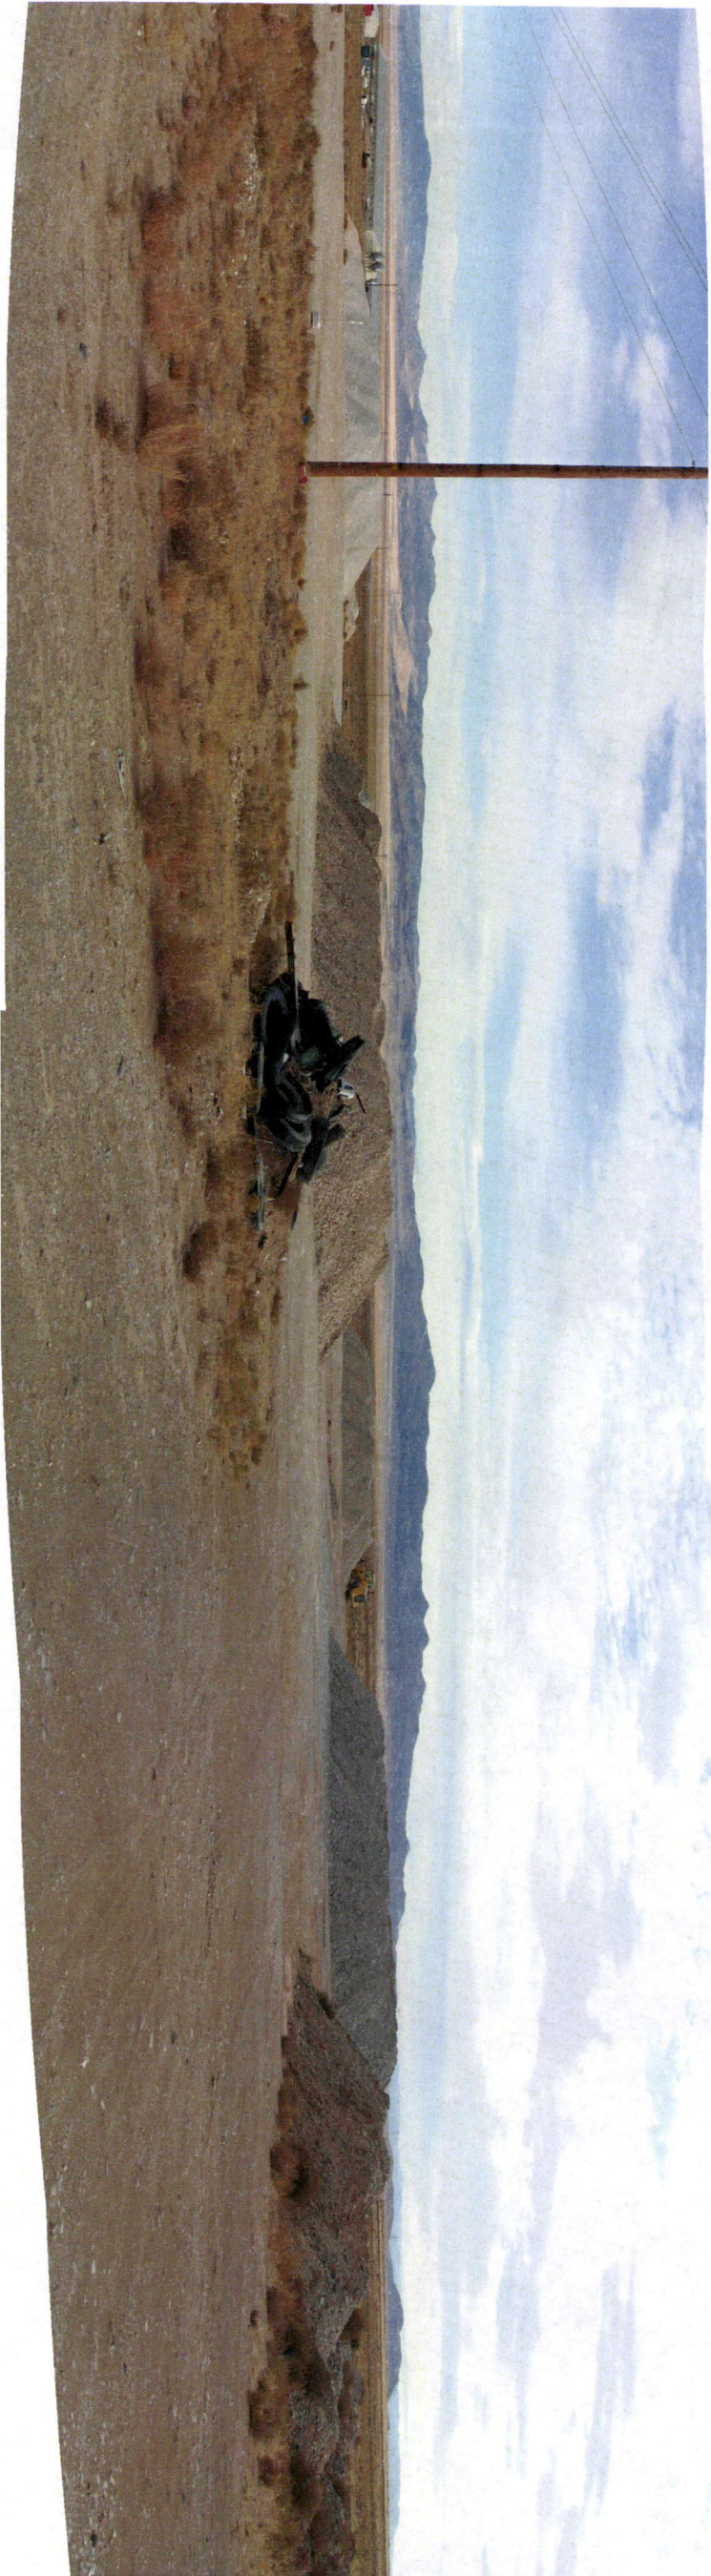
UTU-80852: Blawn Mtn. Kaolin
October 22, 2009

Panoramic view of operator's stockpiling/transfer area located on private land south of the Hog Farm Road on the west side of the Escalante Valley.
